# Digital Teardowns Are Here: How Ultrasound Inspection of Every Cell Produced Transforms Battery Manufacturing Quality and Economics

## Executive Summary

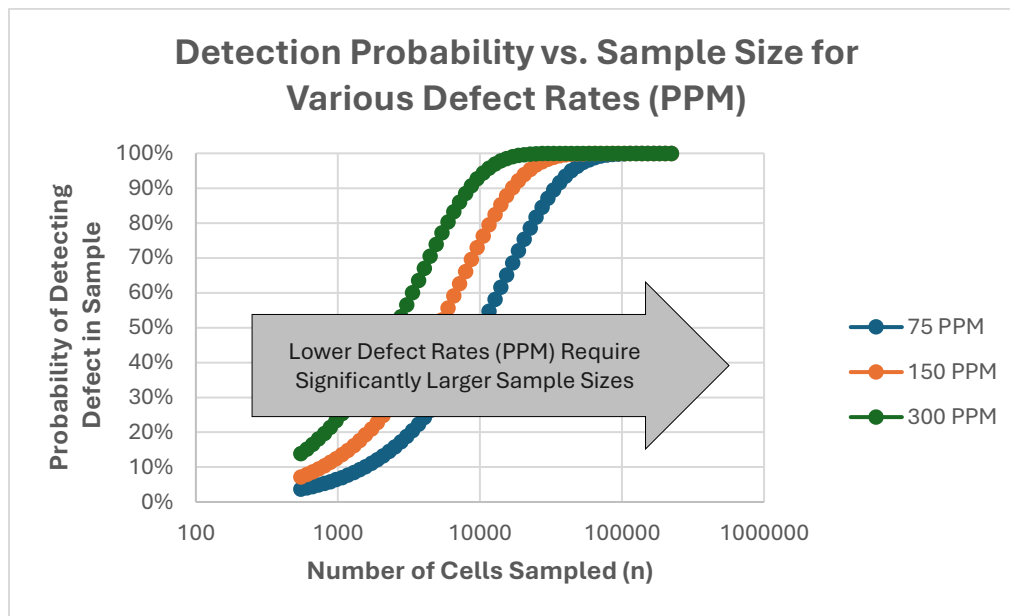
Figure 1. **The Challenge of Detecting Low-PPM Defects with Sampling Inspection.** This chart illustrates that achieving a high probability of detecting a defect present at a low parts-per-million (PPM) rate requires inspecting a very large sample of cells. For example, reliably catching defects occurring at rates below 300 PPM necessitates sampling tens of thousands of cells, rendering sampling-based methods like offline CT impractical for comprehensive quality assurance in high-volume production.

- **Sampling Inadequacy:** Consequently, CT is used for offline analysis or minimal sampling, inspecting only a tiny fraction of production. This statistical sampling creates significant risk. As illustrated by the challenge of detecting low-PPM defects (Figure 1), reliably catching defects occurring at rates common in scaled manufacturing (e.g., 100-1000 PPM) requires inspecting tens of thousands of cells per batch—impossible with CT sampling. Resorting to small sample sizes statistically guarantees that critical defects will bypass inspection.

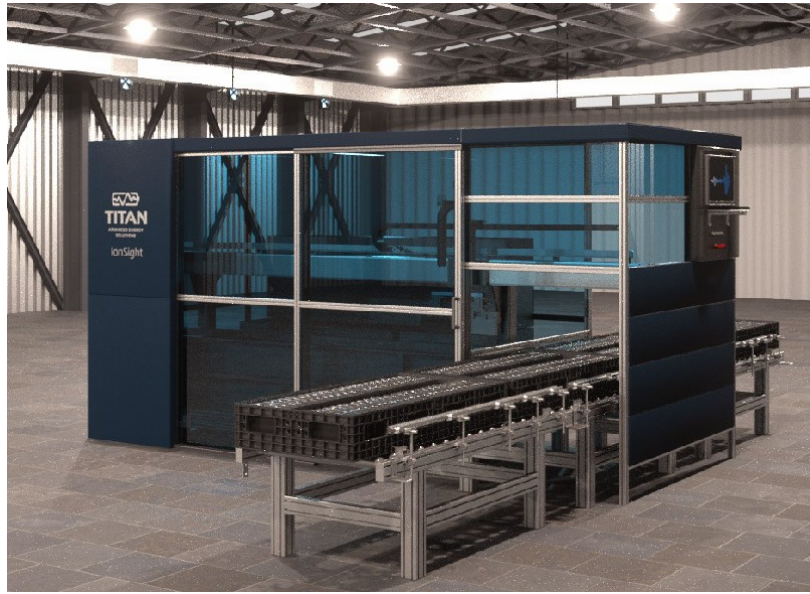
Figure 2. **Titan's IonSight™ inspection platform.** This rendering illustrates Titan's most recent system engineered to perform automated, in-line 'Digital Teardowns' of battery cells using advanced ultrasound tomography.

At its core, IonSight utilizes arrays of custom ultrasonic transducers. During inspection, these sensors interrogate each cell by emitting and receiving focused ultrasound pulses at tens of thousands of unique locations, generating an unprecedented level of acoustic detail about the cell's internal state (conceptualized in Figure 3).

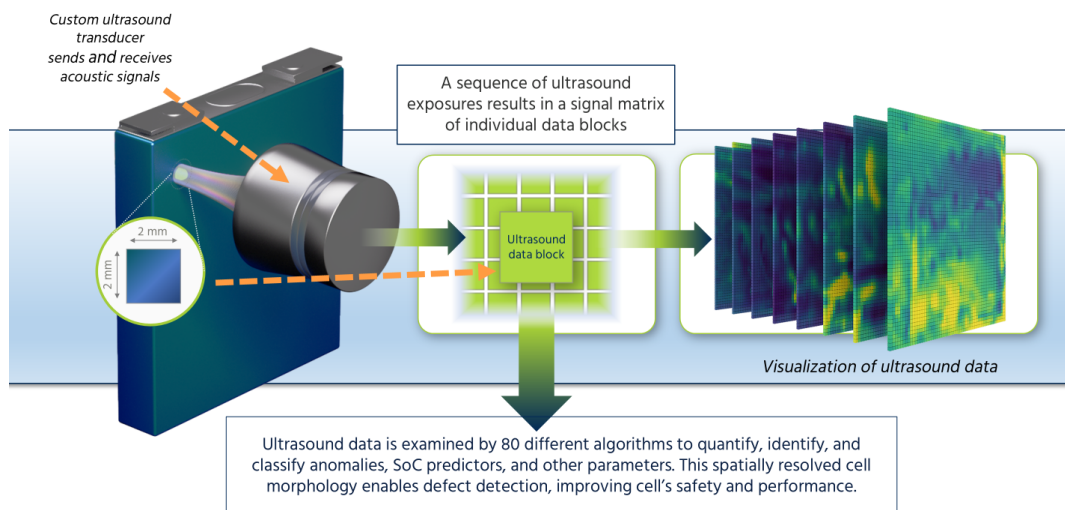
Figure 3. **IonSight Ultrasound Data Acquisition, Processing, and Visualization.** Custom ultrasound transducers send and receive acoustic signals at thousands of discrete locations on the cell. This sequence of exposures generates a rich signal matrix (data blocks). Sophisticated algorithms analyze this data to identify and classify anomalies and other parameters. The spatially resolved data is then visualized as cross-sectional "slices," providing a detailed view of the cell's internal morphology for defect detection and quality assessment.

Sophisticated Digital Signal Processing (DSP) analyzes the received ultrasound signals from each point, extracting key features like signal attenuation, time-of-flight, and scattering patterns. As shown in Figure 3, this processed data is then fed into a suite of advanced algorithms, including AI/ML models trained on battery-specific defect signatures. These algorithms automatically identify, classify, and quantify internal anomalies with high precision, enabling the **direct detection of defects often missed by electrical testing**.

This systematic, point-by-point interrogation generates a comprehensive acoustic dataset—a spatially resolved signal matrix representing the cell's internal characteristics (Figure 3). This forms the foundation of the **Digital Teardown**. The data is computationally reconstructed into virtual cross-sectional images or "slices" (also depicted in Figure 3), revealing the internal structure and potential defects layer by layer. This detailed internal view empowers manufacturers to confirm structural integrity, pinpoint subtle flaws, and gain actionable quality insights for **every cell** before it progresses further in manufacturing or leaves the factory.

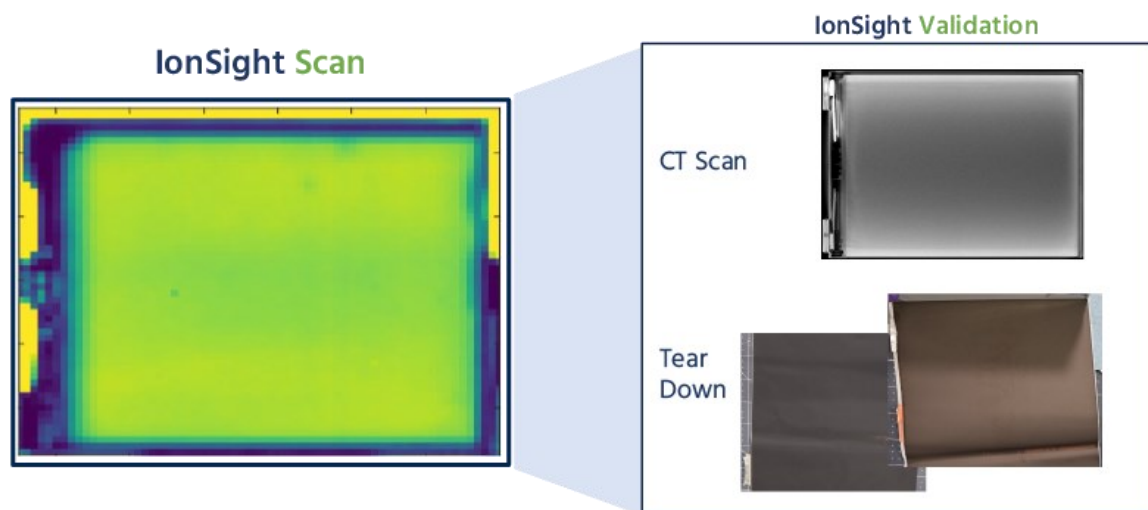
Figure 4b. **Baseline Uniformity in a "Good" Cell.** The IonSight scan (left) of a 100 Ah LFP cell shows high acoustic uniformity. This finding is validated by the uniform appearance in the CT scan (top right) and the physically intact electrode stack observed during teardown (bottom right), establishing the visual signature of a high-quality cell.

The IonSight scan (left panel, Figure 4b) displays a highly uniform acoustic response across the bulk of the electrode stack. This uniformity typically indicates consistent electrode adhesion, uniform electrode density, and proper electrolyte wetting—key attributes associated with reliable performance and long cycle life. This interpretation is validated by the corresponding CT scan (top right panel), which also shows good structural uniformity, and by the physical teardown image (bottom right panel), confirming intact and uniform electrode layers were present within the cell. This clear baseline signature of a high-quality cell serves as a reference point for identifying deviations linked to defects in the subsequent examples.

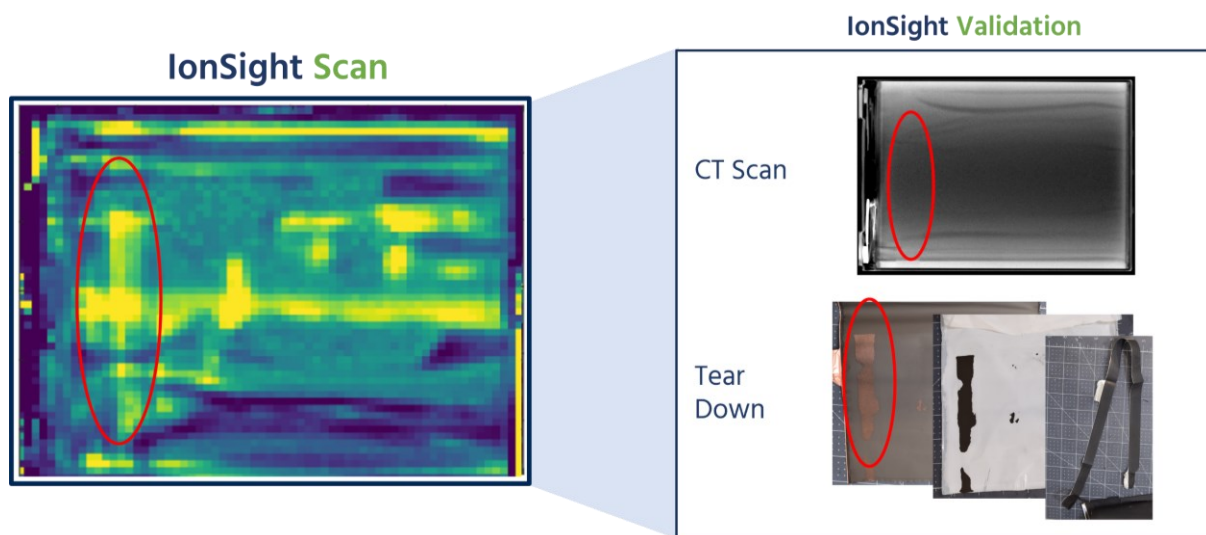
Figure 6. **Anode Delamination and Missing Cathode Material.** IonSight scan indicates delamination and layer anomalies (circled region). Teardown confirms anode delamination and a significant tear resulting in a missing cathode section. In-field expectations: Lower capacity, potential for internal short circuit leading to thermal runaway.

The IonSight scan reveals acoustic anomalies (circled) suggesting **anode delamination** and **significant layer irregularities**, indicative of tearing or missing material. Such mechanical defects drastically compromise cell integrity, reducing capacity and critically increasing the risk of internal short circuits and thermal runaway.

Physical teardown confirmed both **anode delamination** and a **major tear resulting in missing cathode material**, directly correlating with the IonSight findings.

Despite containing these hazardous structural flaws, **this cell passed standard electrical QC**. IonSight's ability to identify this type of hidden, critical damage provides essential safety assurance beyond electrical screening.

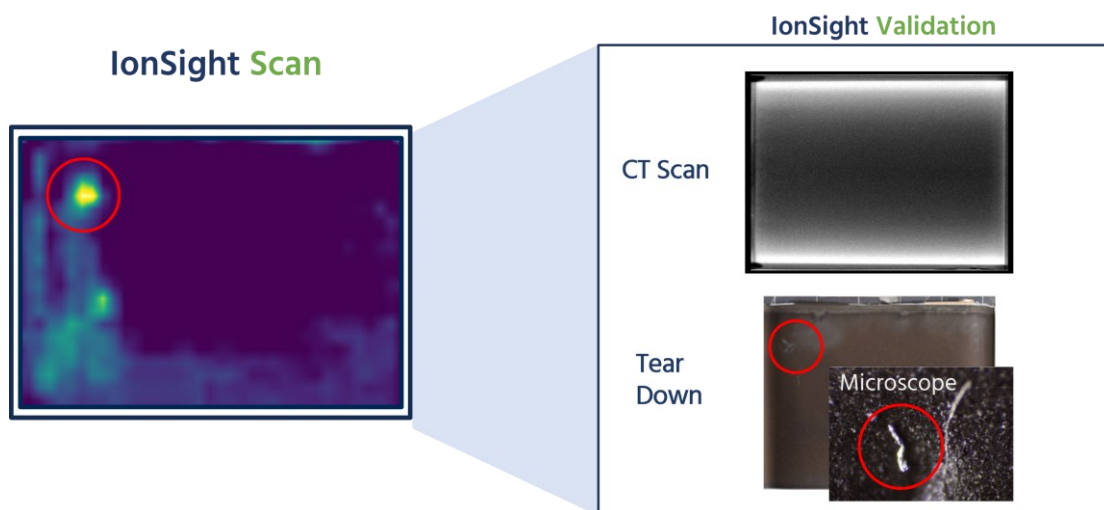
Figure 7. **Lithium Plating Detection.** IonSight scan (left) reveals an anomaly (circled) indicative of lithium plating, which is **not visible** in the corresponding CT scan (top right). Teardown and microscopy (bottom right) confirm metallic lithium plating in the identified region. In-field expectation: Accelerated capacity fade, increased risk of internal short circuit.

Figure 7 illustrates a critical capability: the IonSight scan clearly identifies a localized acoustic anomaly (circled), while the corresponding CT scan of the *same cell region* appears uniform and defect-free.

The distinct signature detected by IonSight is characteristic of **lithium plating**, the hazardous deposition of metallic lithium onto the anode surface. Plating irreversibly consumes active lithium, reducing cell capacity and cycle life. Critically, plated lithium can form sharp, needle-like dendrites that may eventually penetrate the separator, potentially causing internal short circuits and catastrophic thermal runaway.

Validation through teardown, followed by microscopic examination of the suspect area, confirmed the presence of **metallic lithium plating**, precisely correlating with the anomaly detected by IonSight.

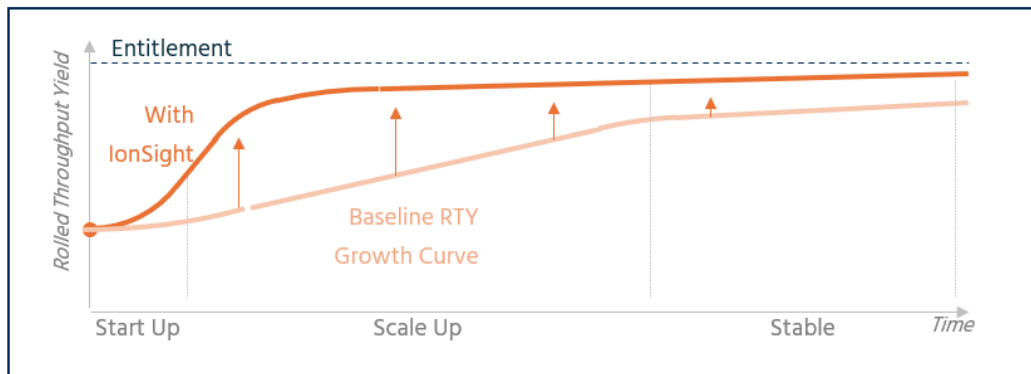
Figure 8. **Accelerating Yield Improvement with IonSight.** The Digital Teardown enables faster process learning and stabilization, leading to a steeper Rolled Throughput Yield (RTY) curve during ramp-up and a higher sustained yield in stable production compared to baseline methods relying on delayed feedback from sampling or electrical tests alone.

The impact of implementing effective corrective actions, enabled by faster feedback and 100% inspection, translates directly to improved manufacturing economics, **as visualized in Figure 8**. Faster problem-solving and reduced defect rates increase the Rolled Throughput Yield (RTY) —the probability that a unit passes through all manufacturing steps without defects. Higher RTY means lower scrap and rework, directly reducing the Cost of Quality (COQ) and boosting the factory's Gross Margin (GM).

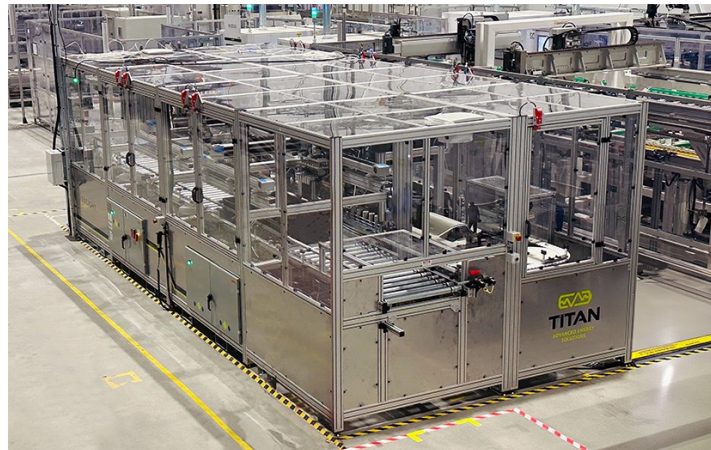
*Figure 9. IonSight Atlas 1.0 deployed at a gigafactory*

Implementing IonSight's Digital Teardown capability is designed for straightforward integration into existing high-volume battery manufacturing lines. The physical system is engineered to interface with standard cell conveyance and automation systems, minimizing the need for major line alterations. Required modifications to the production workflow are typically minimal, primarily involving the allocation of space and standard connections for power and data. Operator training focuses on system monitoring and basic maintenance, leveraging intuitive interfaces, while flexible implementation plans allow for phased rollouts aligned with specific production schedules and goals.
